No. 156

METALLOGRAPHIC FEATURES REVEALED BY THE DEEP ETCHING OF STEEL

H. S. RAWDON, Physicist
SAMUEL EPSTEIN, Laboratory Assistant
Bureau of Standards

ISSUED MARCH 19, 1920

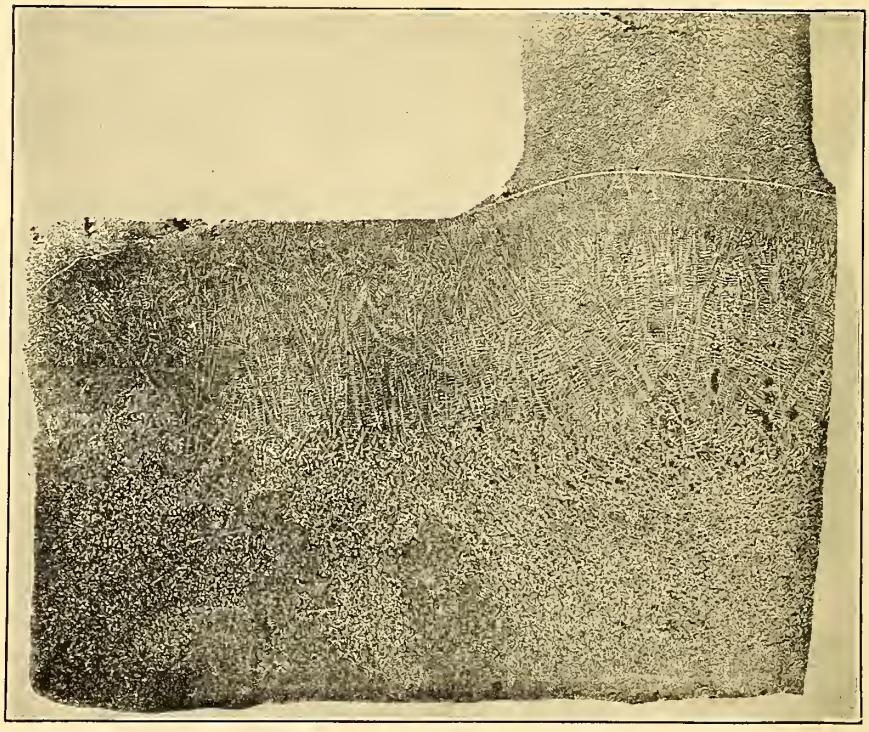
Fig. 2 illustrates a condition which has resulted from what may be termed "secondary segregation." The photograph shows a section of a large steel casting which, although it met the prescribed specifications as to mechanical properties and heat treatment, fractured as a result of the handling received during transportation. The composition is given in Table 1. The macroscopic examination of the material after deep etching, together with the subsequent study of the microstructure, showed that although a sufficient grain refinement had been brought about by the annealing which the material had received (72 hours at 900° C (1650° F), cooled in furnace) the material still

FIG. 2.—*Chemical inhomogeneity of cast steel revealed by deep etching*

The specimen was photographed after being moistened with glycerin. Although the steel casting was annealed for 72 hours at 900° C, the original dendritic pattern persists. The distribution of the impurities, originally located in the angles between the dendrites, has not been changed by the treatment. ×½

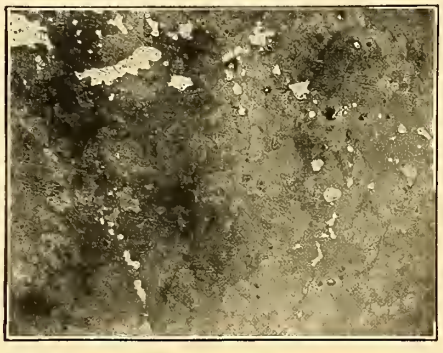
FIG. 3.—*Porous condition of cast steel*

Same material as Fig. 2, heat tinted. The white spots which are due to the exudation of alcohol and water used for washing from within the metal have prevented the uniform coloring of the surface. Each spot marks a spongy area. ×25

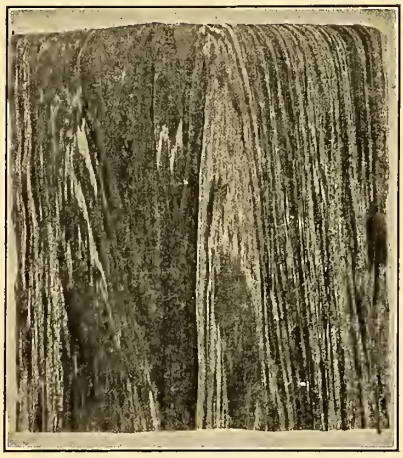
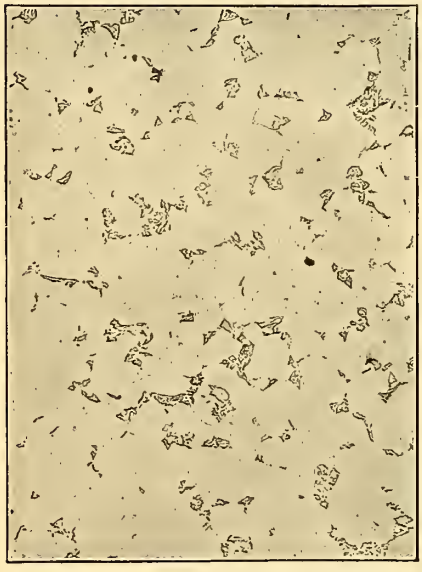
A special application of the use of deep etching in the inspection of wrought iron is illustrated by Figs. 4 and 5. Wrought iron, when ground smooth or filed and then etched with concentrated acid,[4] shows the presence of steel streaks by the white glistening appearance of such streaks; the body of the wrought iron remains dark. Fig. 4, *a*, shows the appearance of a large commercial wrought-iron shackle which was examined to determine its purity. The white streaks are of steel and have the structure shown by Fig. 4, *b*.

(*a*) Polished specimen of commercial wrought iron, deeply etched in concentrated hydrochloric acid. ×1

(*b*) Microstructure of one of the white bands of (*a*) above. The material of the bands has the structure of low-carbon steel. Etching, 2 per cent alcoholic nitric acid. ×100

FIG. 4.—*Chemical inhomogeneity of commercial wrought iron revealed by deep etching*

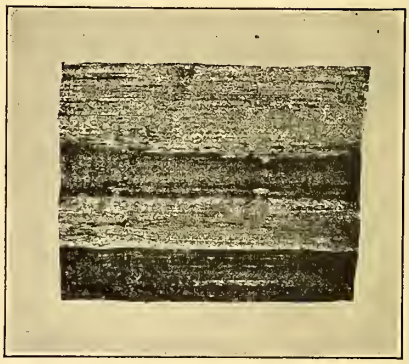
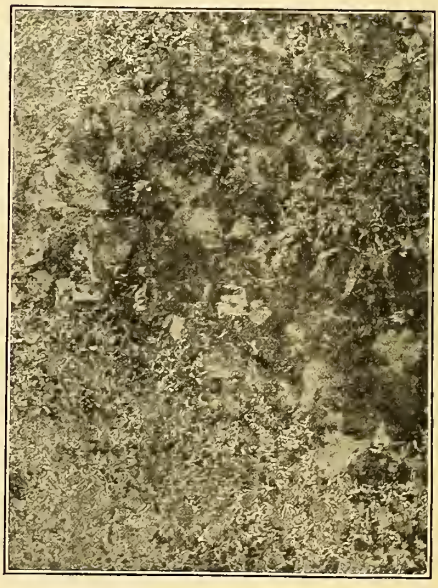
Fig. 5 shows the results of a similar examination of a bar of high-grade Swedish iron. The light streaks are of steel of a composition approaching that of eutectoid steel.

(*a*) Polished specimen of Swedish wrought iron deeply etched in concentrated hydrochloric acid. ×1

(*b*) Microstructure of one of the white bands of (*a*). The material here has the structure of a steel of nearly eutectoid composition. Etching, 2 per cent alcoholic nitric acid. ×100

FIG. 5.—*Chemical inhomogeneity of high-grade Swedish wrought iron revealed by deep etching*

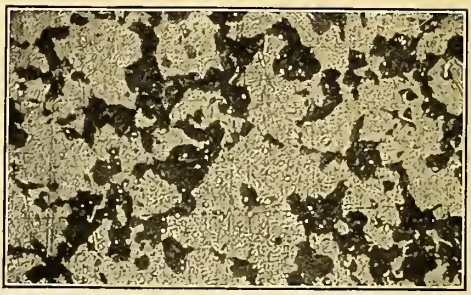
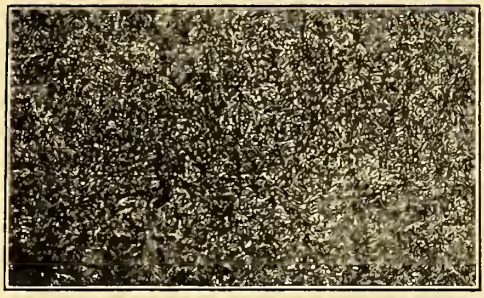
Fig. 7, *a*, *b*, *c*, and *d*, shows the structure of the large (1-inch diameter) balls. The outer metal has been rendered martensitic to the depth shown in Fig. 7, *a*. The central portion is largely troostitic. In Fig. 8 the structure typical of the small and the medium sized balls is shown.

(*c*) Microstructure of the intermediate thin zone between the outer light-colored layer and the dark-colored central sphere of (*a*). This transition zone consists of martensite and troostite with some specks of carbide. ×500

(*b*) Microstructure of the outer spherical layer (light-colored) of (*a*). This layer is martensitic throughout with tiny globules of cementite. ×500

(*a*) Microstructure of the central sphere of (*a*). The metal is largely troostite with specks of carbide. None of the balls of this size split when deeply etched with concentrated acid. Etching, throughout, 2 per cent alcoholic nitric acid.

FIG. 7.—*Structure of hardened steel balls*

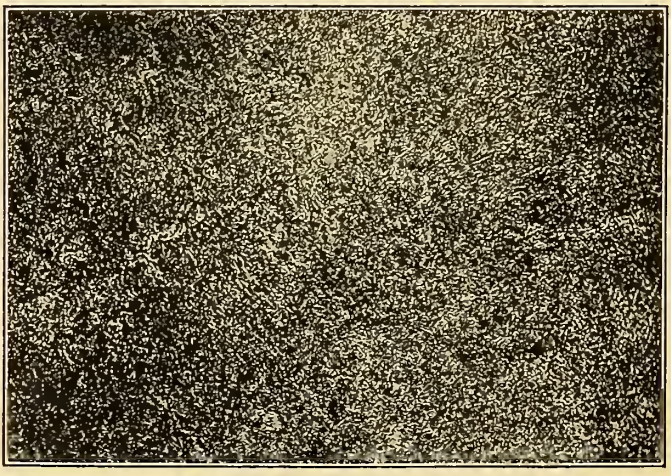
These specimens were martensitic throughout. This difference in microstructure is in accordance with the results of the etching tests—only the severely hardened specimens showed any tendency to split upon deep etching. It will be noted in Table 2 that the balls of one-half inch diameter are of a steel containing no alloying element and of a carbon content considerably lower than that of either of the other two. In order to render this steel relatively as hard as the other two types, a much more severe treatment must be resorted to, and this fact probably accounts largely for the greater tendency of this series to split than the other two. That the mechanical work which the material received (i. e., the magnitude of the internal stresses) also contributes to the tendency to split is evident in view of the fact that balls of similar size and hardness (i. e., as indicated by the structure) turned out in the lathe rather than forged or pressed showed no tendency to split upon etching.

Microstructure of the balls one-half and three-eighths inch in diameter. These balls were martensitic throughout. This structure is typical of the specimens which split when deeply etched with acid. Etching, 2 per cent alcoholic nitric acid. ×500

FIG. 8.—*Microstructure of hardened steel balls*

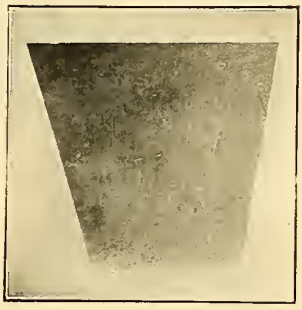
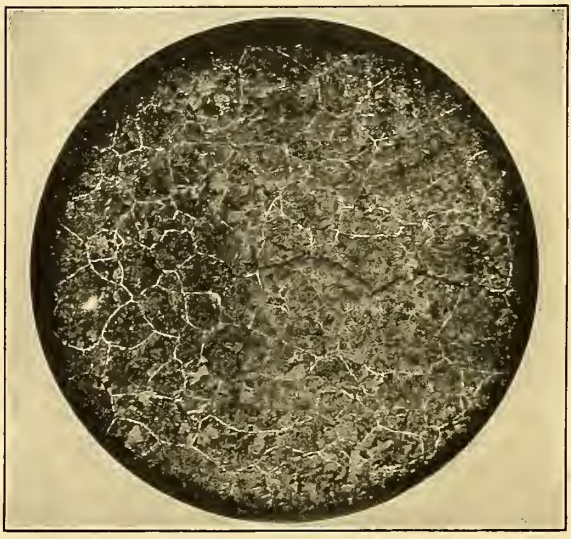
In Fig. 9 is shown the appearance of a specimen of a defective gun forging (composition: Carbon 0.38 per cent, chromium 0.20 per cent, nickel 2.92 per cent) in which the defects are quite readily detected after polishing. Deep etching accentuates these by widening and deepening the fissures.

Fig. 9, *c*, shows the appearance of a section of a 1-inch round trepanned out of a large bloom of gun steel similar to that of the forging of Fig. 9, *a*, suspected of being defective. Subsequent deep etching revealed the cracks shown in Fig. 9, *c*. Presumably the cracks here revealed are identical with the defects found in the finished forging (Fig. 9, *a* and *b*). It will be noted that the crack is intercrystalline for the greater part of its course.

(*a*) Transverse radial section from a forging for a gun tube polished to show interior defects. ×1

(*b*) Specimen (*a*) after deep etching in concentrated hydrochloric acid. The defects readily visible in (*a*) have been greatly widened and deepened by the etching. ×1

(*c*) Cross section of a 1-inch "round" trepanned out of a large bloom intended for a gun tube, etched with 2 per cent alcoholic nitric acid. The crack, which undoubtedly is of the same origin as the defects in (*a*) and (*b*), probably originated at a rather high temperature. It is largely intercrystalline in its course. ×3

FIG. 9.—*Defects in gun forgings revealed by deep etching*

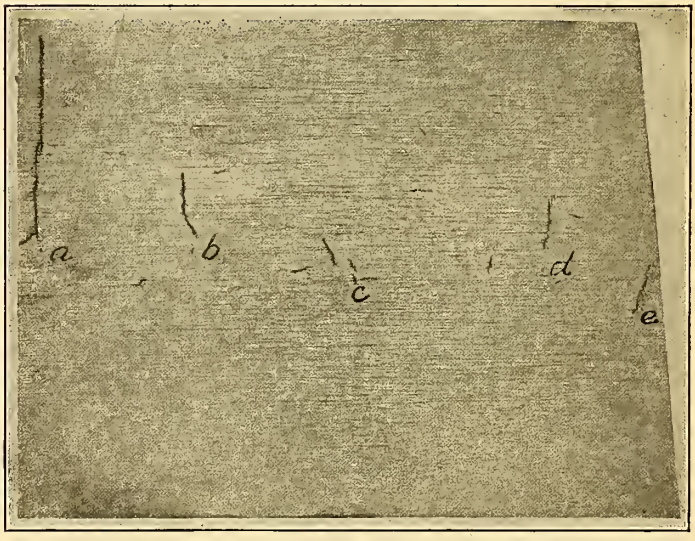
In Fig. 10 is shown the appearance of a slice from the lower part of the head of the rail No. 3, which has been treated with the iron dust after magnetizing and the same specimen after deep etching. It is extremely difficult to photograph the specimen so as to clearly show the results of the treatment with iron dust. They are much more readily seen upon visual examination than might be inferred from the photograph. Comparison of Fig. 10, *a* and *b*, however, shows the presence of a very fine crack or discontinuity in the unetched specimen (Fig. 10, *a*) corresponding to each of those revealed by deep etching (Fig. 10, *b*).

(*a*) Longitudinal section of the head of rail No. 3 (Table 4) parallel to the tread. The specimen was magnetized and then immersed in kerosene in which iron dust was suspended. The cracks indicated by *a*, *b*, *c*, *d*, and *e* were located

(*b*) Same specimen as (*a*), deeply etched with concentrated hydrochloric acid. The cracks revealed by deep etching correspond with those in (*a*). ×1

FIG. 10.—*Defects in rails containing transverse fissures revealed by deep etching*

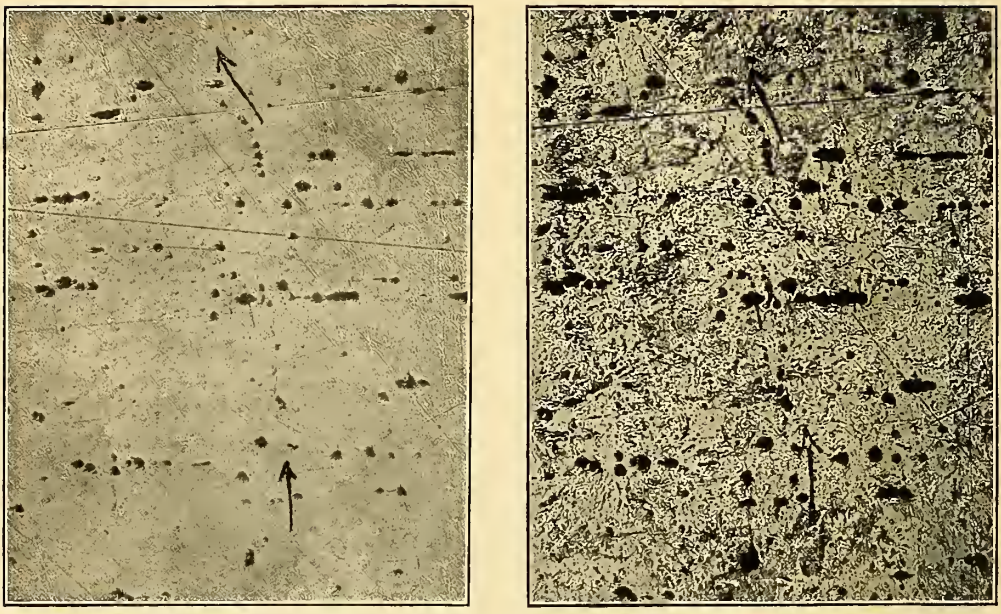
Although it is known with certainty that a discontinuity exists in the metal between the two punch marks, it is extremely difficult to find evidence of it in the microstructure even after light etching. In Fig. 12 is shown the best indication found of the presence of such a crack. This is very faint, however, and would be disregarded in the ordinary microscopic examination as of little or no importance. The faces on the opposite sides of the discontinuity or fissure are in such intimate contact that even at a magnification of 500 diameters the crack is relatively very inconspicuous, as is shown in Fig. 13. The course of the crack which has been indicated by arrows is hardly more conspicuous than the dark boundaries of the pearlite masses.

FIG. 12.—*Microscopic appearance of cracks existing in rails of the transverse-fissure type*

(*a*) Crack (*b*) of Fig. 10, *a*, specimen is unetched. ×50
(*b*) Same specimen as (*a*), etched with 2 per cent alcoholic nitric acid. The metal is in such intimate contact that only a very faint indication of the presence of the crack could be obtained. ×50

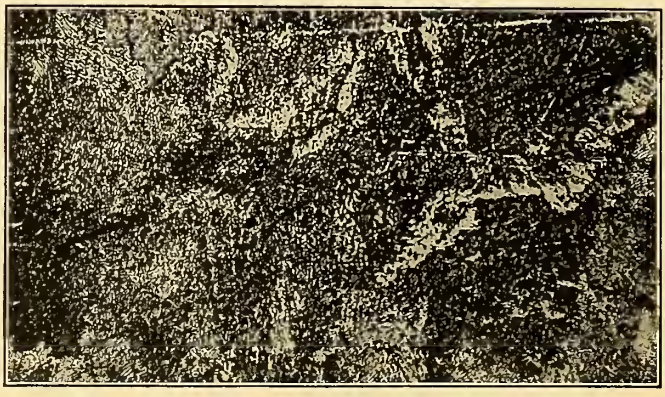
FIG. 13.—*Microscopic appearance of interior cracks existing in defective rails*

Crack (*b*) of Fig. 10, *a*, is shown after etching. ×500. The two sides of the crack are in such intimate contact that even at this magnification the course of the cracks (indicated by arrows) is relatively very inconspicuous.

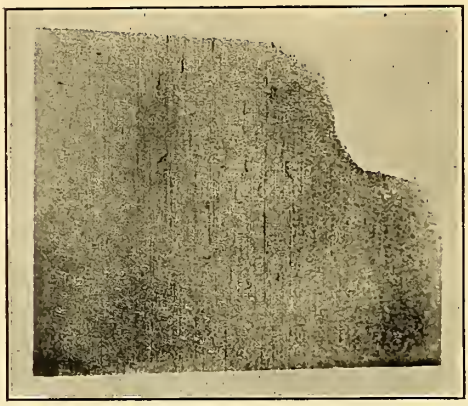
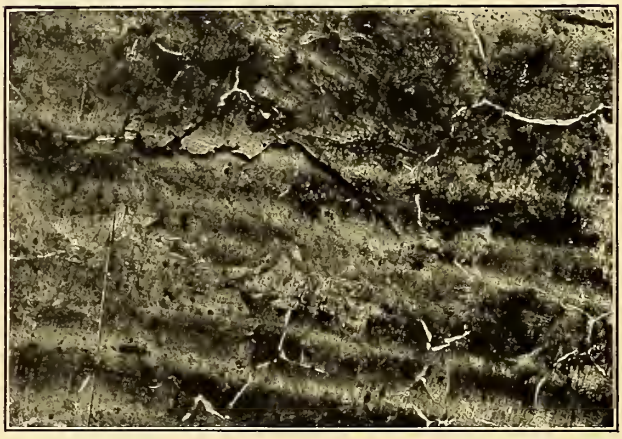
(*a*) Longitudical section of rail No. 2 (Table 4) parallel to the tread. The interior cracks as they appear after slight etching with concentrated hydrochloric acid. ×1

(*b*) Specimen (*a*) after slight etching in concentrated hydrochloric acid to widen the crack, repolished for microscopic examination. The crack is intracrystalline in its course. There is some evidence of banding due to phosphorus. Etching, 2 per cent alcoholic nitric acid. ×100.

(*c*) Same material as (*b*). The intracrystalline nature of the crack is very evident. Etching, 2 per cent alcoholic nitric acid. ×500

FIG. 15.—*Microscopic nature of the interior defects found in rails of the transverse-fissure type*

to be very suitable for this purpose. Fig. 15, *a*, shows a section of this rail after slight etching with concentrated hydrochloric acid. The interior cracks having been widened by the concentrated acid, the surface was ground down, repolished, and reetched for microscopic examination. In Fig. 15, *b* (×100), and Fig. 15, *c* (×500), a crack is shown passing through the grains and across the grain boundaries. The cracks are intracrystalline, in their course; that is, the break has occurred *through* the grains rather than *between* them.
